SNOQUALMIE RIVER CED RETROFIT

FEBRUARY 16, 2005

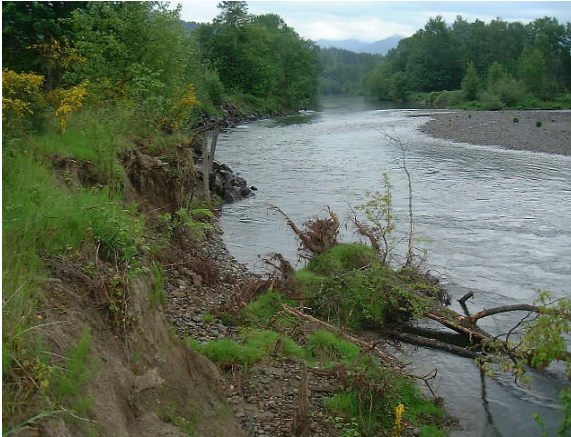
Figure 1. Snoqualmie River CED site showing bank erosion prior to retrofit project construction.

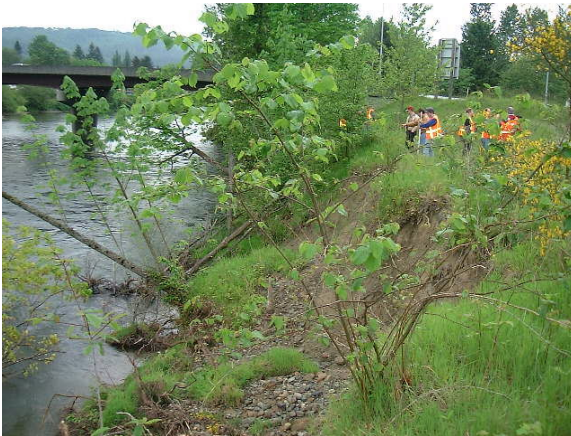
Figure 2. Snoqualmie River CED retrofit project showing bank erosion prior to retrofit project construction.

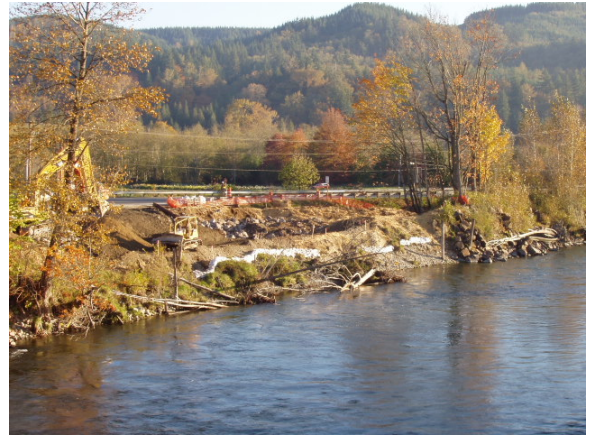
Figure 3. Snoqualmie River CED retrofit project during construction (October 27, 2004).

Buried woody groins were used at this site to fix the erosion problem. The groins were installed between the eroding bank and SR 202. As the channel erodes and exposes the buried groins, roughness will be created along the new bank and the thalweg alignment along the groins' tips will be maintained. The woody debris along with the scour holes that will form at the tip of the groins will increase salmonid habitat within this reach. The top of the bank was planted with woody vegetation to help with bank stabilization and restore lost riparian function. The reestablishment of riparian vegetation at the site provided functional self-mitigation for the project itself.

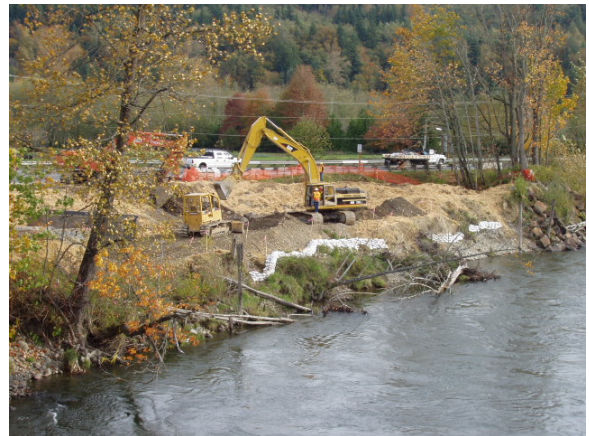
Figure 4. Snoqualmie River CED retrofit project during construction (October 27, 2004).

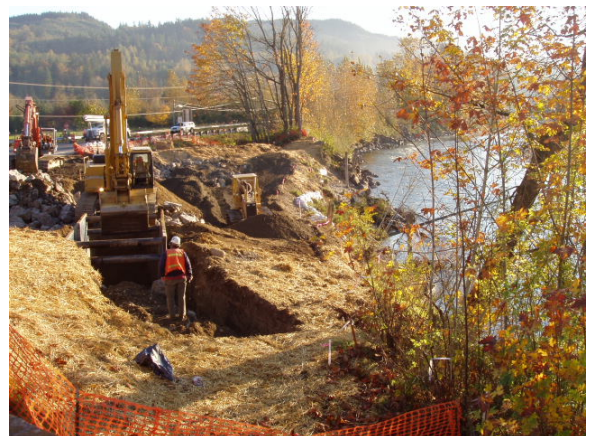
Figure 5. Snoqualmie River CED retrofit project during construction (October 27, 2004).
